An Exploration of Corrosion in the HF Neutralization Section at Linear Alkyl Benzene Production Plant

ABSTRACT: *The Hydrofluoric acid (HF) is a catalyst for the production of linear alkyl benzene (LAB). In this research the corrosion and perforation in the overhead line of HF neutralization section in Bistoun Petrochemical Company (BPC), at Iran was investigated. The accumulation of sediment and under deposit corrosion has resulted in the perforation of the mentioned line. The main causes of failure were explored by visual checking, chemical characterizations, scanning electron microscopy (SEM), and X-ray fluorescence (XRF). The effects of process conditions, pipeline design, water content and oxygen amounts were studied. Corrosion and perforation in the line is based on the composition of the liquid or gases passing through the line and operating conditions. The reverse return of water vapors contaminated with KOH from relief gas scrubber to overhead line can accelerate the corrosion. Lastly, the suggestions have been proposed for trouble shooting, prevention from failure in the line and HF leakage.*

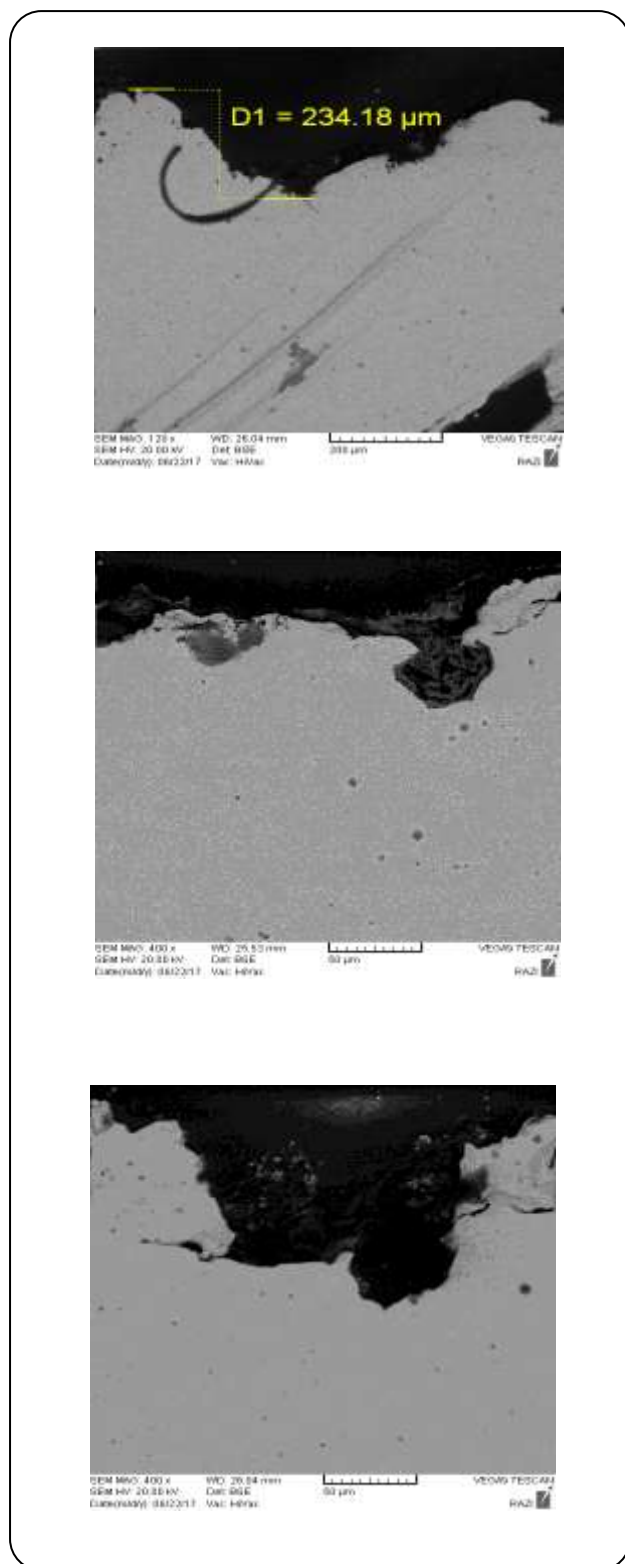
The surface topology and imaging corrosion products on the inner surface of the overhead line were studied by SEM images (Fig. 2 A, B, C). After removing the huge amounts of fouling accumulated in the tube, the analysis of the surface of the tubes displayed that these sediments are frequently based on iron oxides. It was found that the thickness of the oxide layer in different parts was until 234.18 microns (Fig. 2 A). The thick and porous

Fig. 2: A) The depth of the cavities observed in different areas of the inner surfaces of the line. B) The thickness of the deposited oxide layer on the inner surfaces of the tube. C) The SEM images of corrosion products.

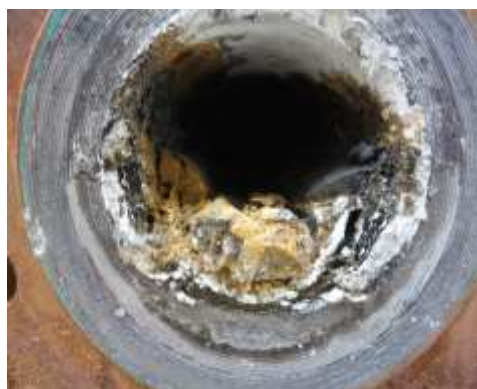
As it can be seen from Fig. 3A, the main part of the wearied line was the middle of the line near the flange. From Fig. 3A& C, it is obvious that the main part of brown deposits is Iron compounds.

As can be seen from Fig. 3 A&C, the inner surface of the line is covered with brownish and white deposits. The presence of such sediments can be originated from under deposit corrosion [10].

Fig. 3: A) The internal corrosion and fouling of the overhead line. B) The outside view of perforated overhead line. C) The cutted view of the overhead line with internal scales and sediments.

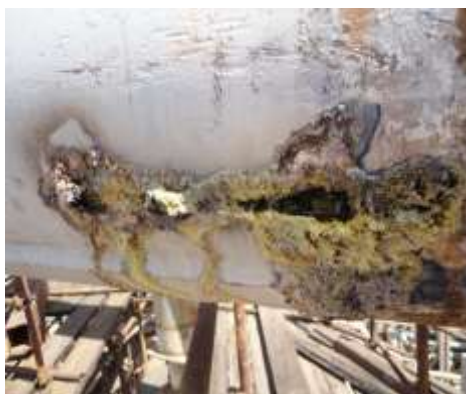
Through the visual check in leakage period, it can be seen that the variation in the corrosion flow pattern is not constant with the known performance, (Fig. 3, B). The total weight-loss discovered in the overhead line through visual check was significant. The visual check from internal and external surfaces presented that perforation is due to pitting corrosion (Fig. 3, B and Fig. 5, B). The study showed that the perforation was started from internal surface and expanded to the external surface.

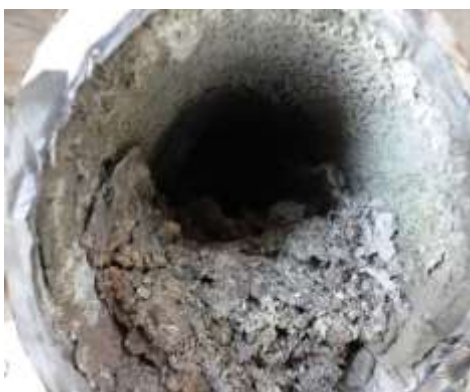
The black deposit was Magnetite but the red deposit has been often Hematite (Fig. 3C and Fig. 5 A). The ferric hydroxide ($\text{FeF}_3 \cdot 3\text{H}_2\text{O}$) has a yellow-brown color whereas Iron fluoride (FeF_2) has a grey color. The black color is characteristic of oxidation (iron II/III oxide) of the steel [13]. A blend of all these colored substances made the scales in the line and supported to the distinctive colors visible when the flange of the line was opened for inspection and maintenance.

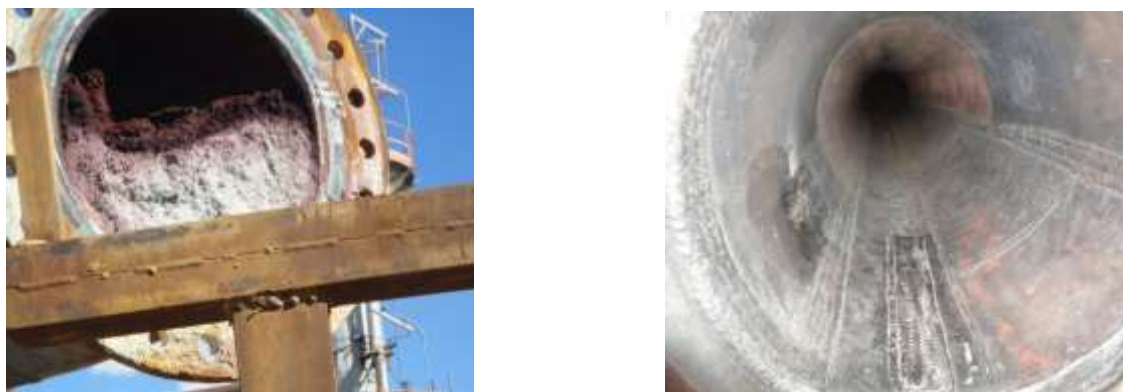
Most equipment in acidic zone is made from carbon steel. Upon contact with highly concentrated acid, a stable iron fluoride layer is formed inside the equipment that provides suitable protection for the carbon steel over more corrosion by HF acid. However, an unstable and porous hydrate scale is shaped in contact with a mixture of acid and water, which swells and can be removed from the overhead line. The pictures were taken from the inner surface of the line by a digital camera, it displayed that the line had a severe cramp, which was choked to some extent in several areas (Fig. 5A).

**Fig. 5: A) Cross-section of the overhead line with huge amounts of sediments and impurities.
B) The cross sectional of the overhead line without deposits after welding.**

The deposited layer is formed by accumulation of solid products; therefore, its density is not as high as that of the passivation film. It is clear from Fig. 5A that a large volume of sediments and nets have been filled the overhead line. Some of these impurities are products of corrosion, but the major part of those compounds is backed from the tower side(T-508) to the overhead line, which is probably due to design or process problems which increases the volume of sediments and Corrosion intensification is subjected to sedimentation. Yellow deposits are probably potassium oxide, and potassium carbonate is also colorless sediment and the XRF results from Table 3 confirmed this subject. Hydrocarbons fumes may also be blocked between sediments and eventually condensed as a result of ambient temperature.

After perforation and welding, the line itself is susceptible to corrosion and the carbon steel resistance decreases because the percentage of key elements such as Cu, Ni and Cr in the welded points is reduced. When carbon steel pipe components with high and low content of residual elements are welded together, severe corrosion can happen.

A suitable pressure difference between the liquid knockout drum and the relief gas scrubber is necessary to prevent from water vapors returned back from the tower towards the overhead line. 2– One of the effective factors is the oxygen problems. By reducing or eliminating oxygen, the corrosion rate is significantly reduced, for this purpose, a continuous injection of a small amount of nitrogen can be used as N₂ sweeper, and in addition the diffusion of oxygen to the equipment should be avoided by holding positive pressure of nitrogen on the liquid knockout drum and taking care while draining it. 3– Changes in design factors such as the slope and cross section of the overhead line can also prevent corrosion that costs the organization. 4– Continually checking the contents of the liquid in the liquid knockout drum and draining immediately if water is present. 5– Controlling the process conditions so that it has the lowest vent of vapors, especially acidic fluids. 6– Due to the fact that replacing the material with Monel cost to the company, it is suggested that the inner wall of the pipe is covered with a layer of Monel sheet (3–5 mm) to prevent corrosion and this is the last solution.
